110 E speedway blvd, tucson az  
Original state of the house , house was vacant for a long time.

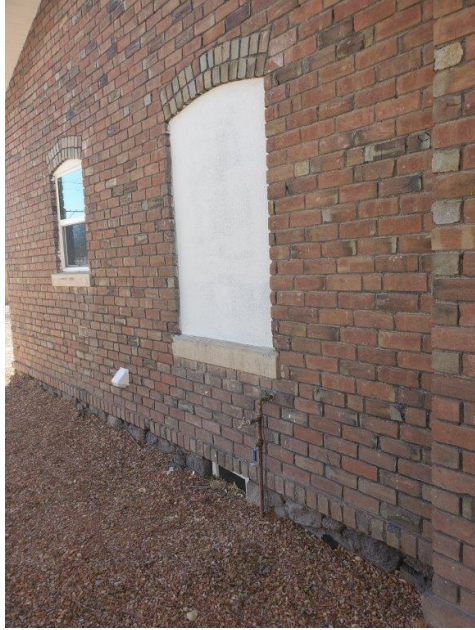
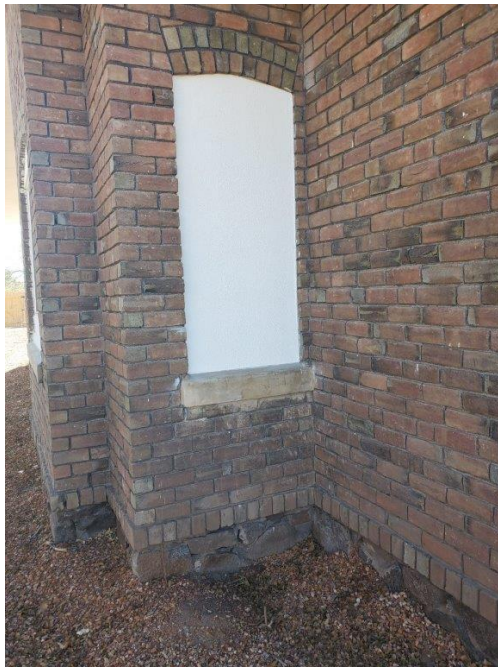
110 E speedway blvd, tucson az

Existing openings not touched, stuccoed and paint over wooden window.

Stucco was placed and paint.

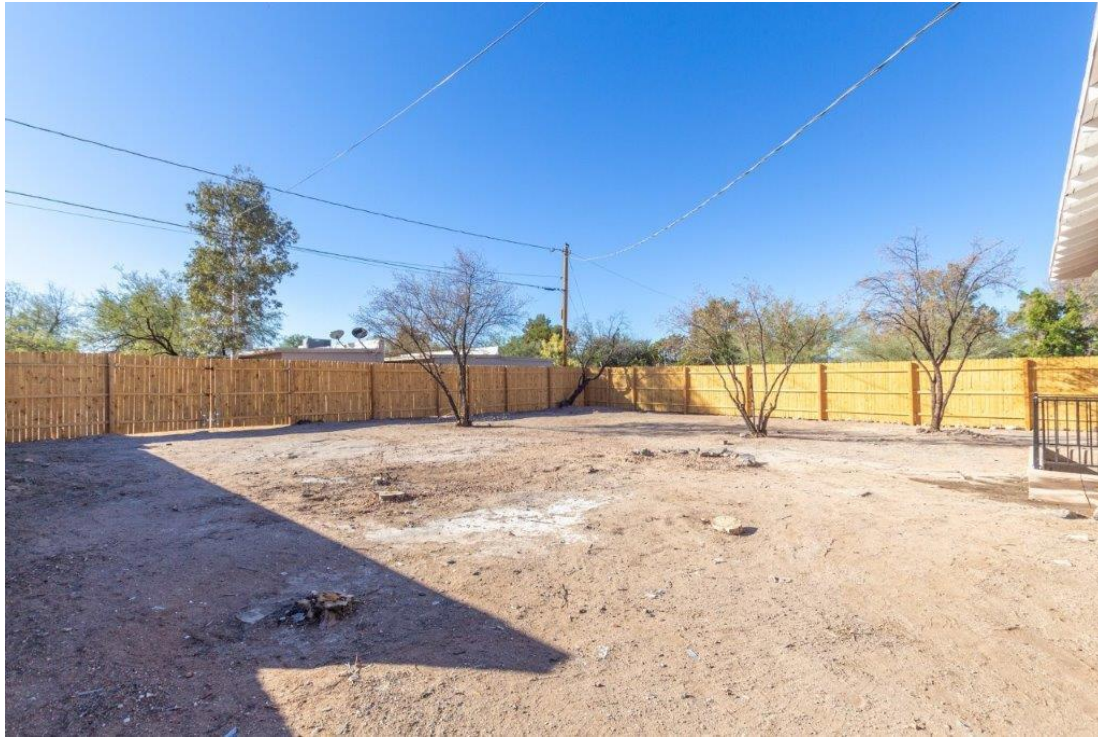
110 e speedway blvd, tucson az

Note -since this home was vacant for a long time, it was a gathering of homeless, the wood was placed to protect it , the house is in the path in between a circle k and homeless park , we were having break ins very often.

Removed old broken chain link fence, had areas missing and replace it with new wooden fence along the west and south sides of the property and the front part on the west side.

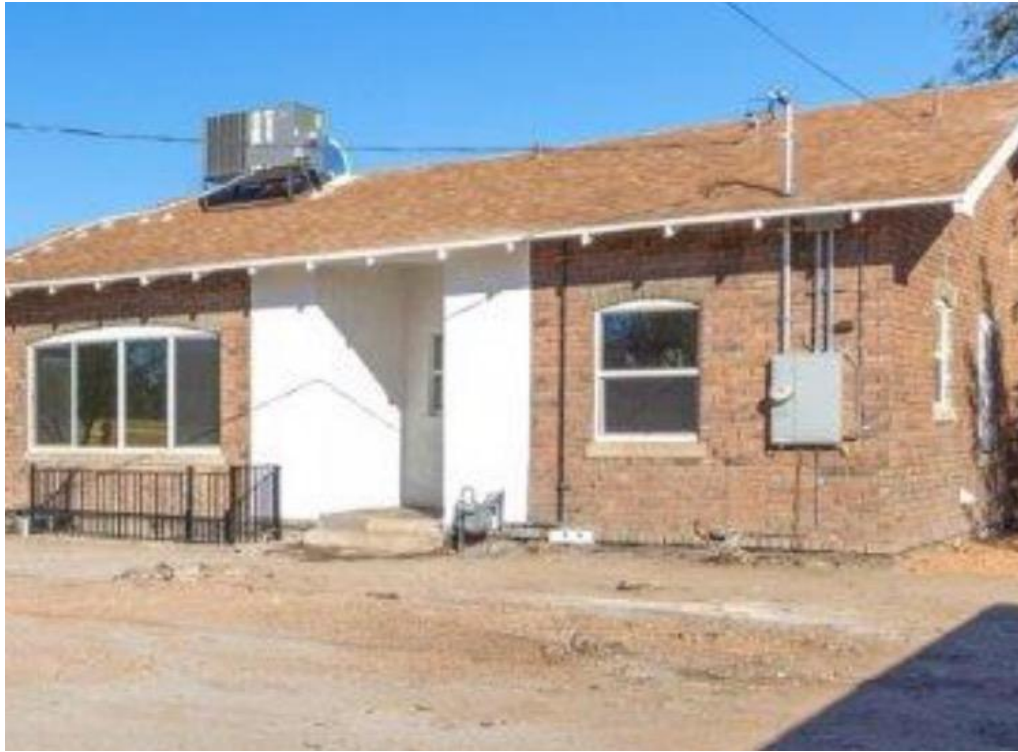
110 E speedway blvd, tucson az

Replaced old shingles with new shingles, existing were in very bad condition , property had signs of leaking due to the condition of the shingles bad condition. Only replaced old for new ones.

Material: Roof was asphalt shingle tiles, replaced with same asphalt shingle til.
